**FREDERICK COUNTY DIVISION OF FIRE AND RESCUE**

**Post Incident Analysis  
Incident # 13 – 3215**

**Date: January 31, 2013  
Location: 3915 Highland Ave.  
Myersville, Md. 21773**

**Prepared by:  
Lieutenant Donald Bennett Jr.  
Battalion Chief Paul Wallick Jr.**

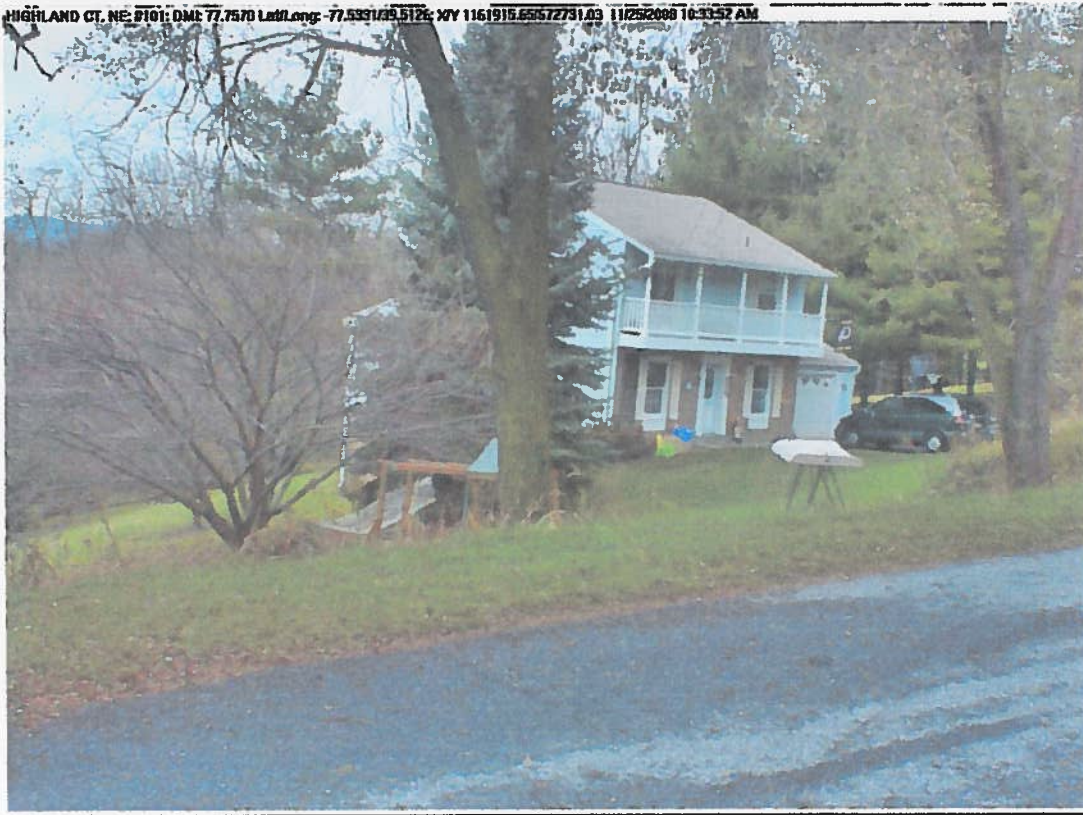
Side Alpha

The structure involved was a two-story single-family home built in 1975. It was constructed with a below-grade basement. The home was of ordinary construction, and it was a three-story house from side "Charlie" of the building. The home was approximately 32' wide by 26' deep with a "Florida" room on the rear "Charlie" side. The home featured a 4' balcony (approximately) that ran the length of the front "Alpha" side of the second floor. The home had an attached one-car garage on the right "Delta" side; this garage had been converted to a half-storage space in the front and a family room in the rear, with a sliding-glass door leading to the back yard. This door was elevated approximately 5 feet from ground level and was blocked by wood railing for safety purposes.
